Case Study: 251 Southwark Bridge: Marble Maintenance

Bringing the wow factor back to a marble floor in a managed block of flats

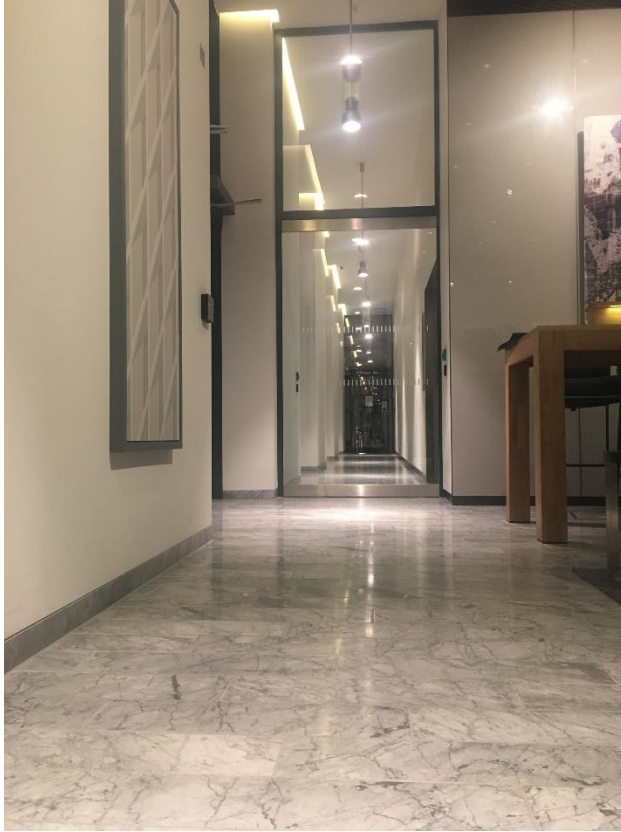
With over 230SqM of Italian marble throughout the communal areas of this luxury block of flats, it was clear from very early on that a specialist maintenance program would need to be in place to ensure that the stone retained its beauty.

We advised a full deep clean and re-polish, to remove etch marks and bring the stone back to a mid-shine that would really show off the intricacies throughout.

Service: Diamond grind and resurface marble floor tiles to remove surface scratches and etch marks. Deep clean tiles and grout lines. Re-polish to 800 grit mid-shine and apply 4 coats of impregnating sealant.
