CASE STUDY

Completed Project | External Cleaning & Stone Masonry Restoration

Historical Building

USL was appointed as Principal Contractor to carry out the sensitive conservation, masonry, maintenance and repair works at the Grade II listed Old Post Office on 1 Cornhill in Ipswich.

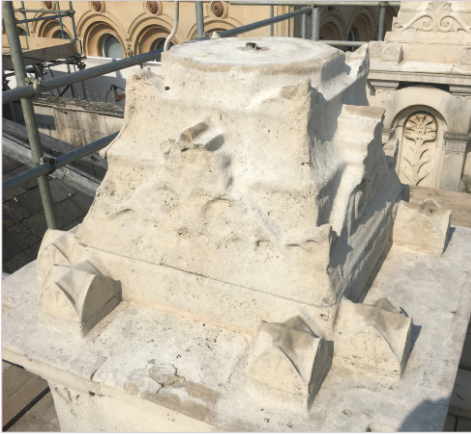
Stone Cleaning & Bases for Urns

- Extensive stone cleaning to North and West elevations by means of DOFF set, where some areas (entablatures to chimneys) required JOS to remove carbon build up between modillions.
- Stone restoration and repairs included two carved panels and cills beneath the portico to be retrieved from cellars to be cleaned, re-carved, repaired and reinstated in place of removed ATM machines.
- Repairs to all stone dressings around chimneys.
- Conservation repairs to ornate high-level stonework including new carvings. Likewise new stone urns were added to the four large 'pepper pots' to which were attached bronze and cast-iron finials.
- Repointing works were carried out in both Stone and Brick including all horizontal joints to projecting courses. Old ferrous fixings were removed with mortar repairs. Much of the brickwork to the chimneys were raked out and repointed.

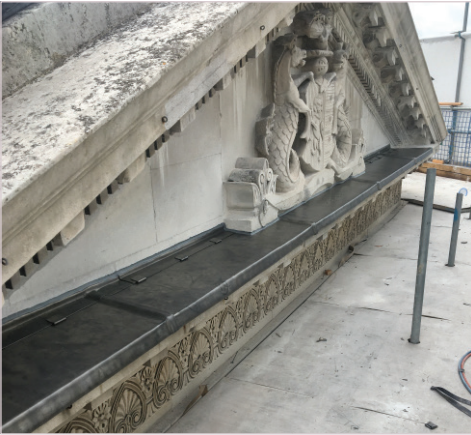
Work in progress

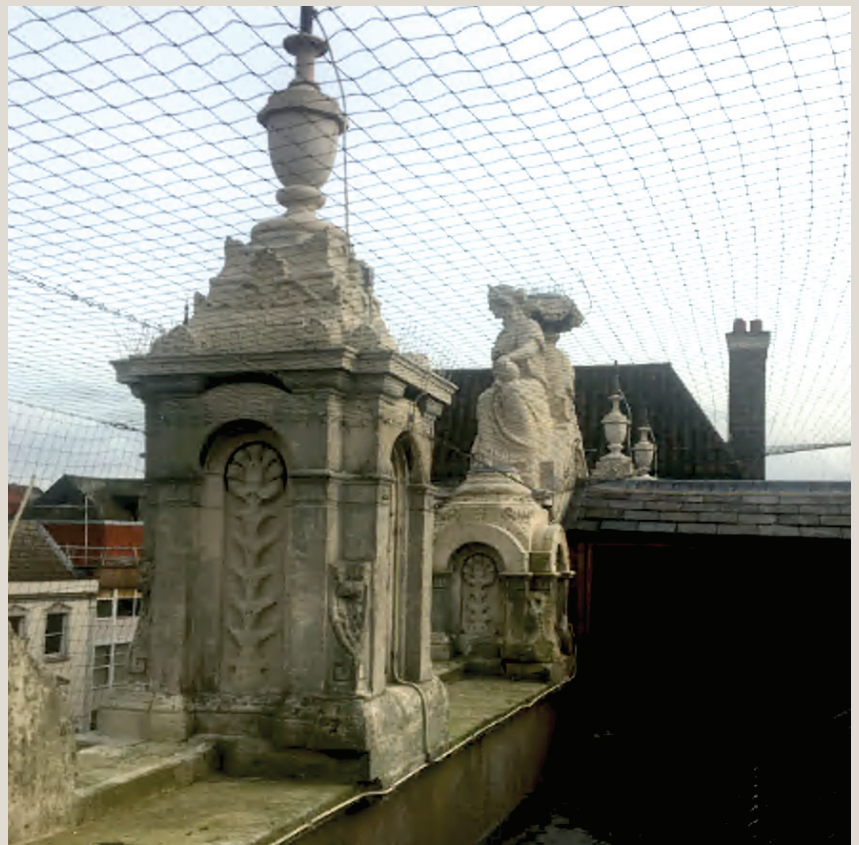
Works in progress

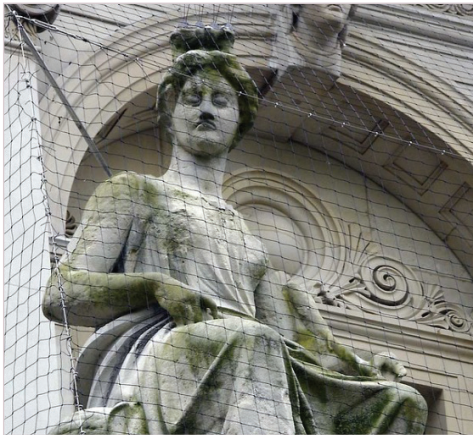
Preworks condition

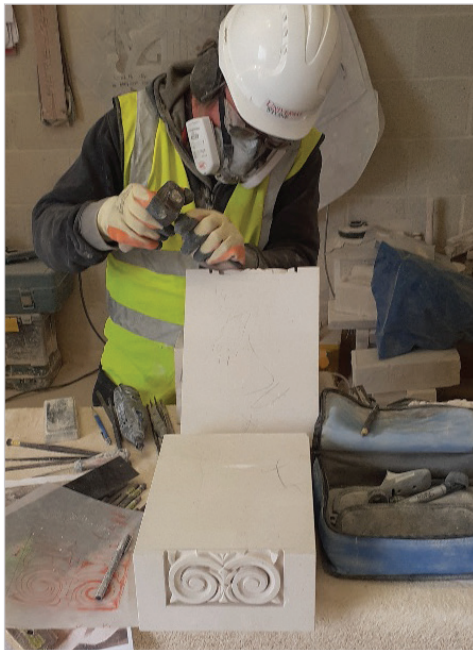
In-house mason carving new panels

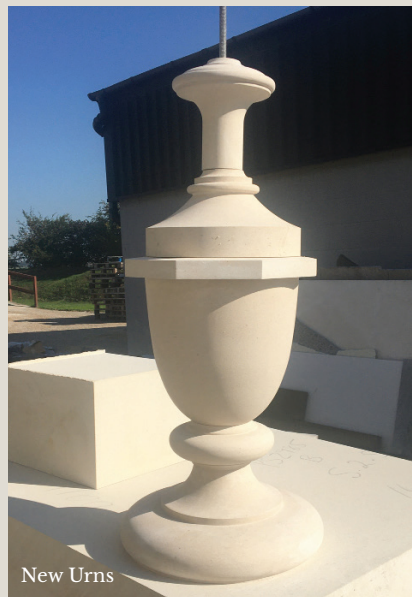
New Urns

- Rainwater Goods Repair to all external downpipes and guttering as removed from site for repairs, cleaning and repainting.
- Following the re-roofing the lightning conductor system as overhauled and refitted. The conductors to the 4 large 'pepper pots' were extended to accommodate the new urns and finials.

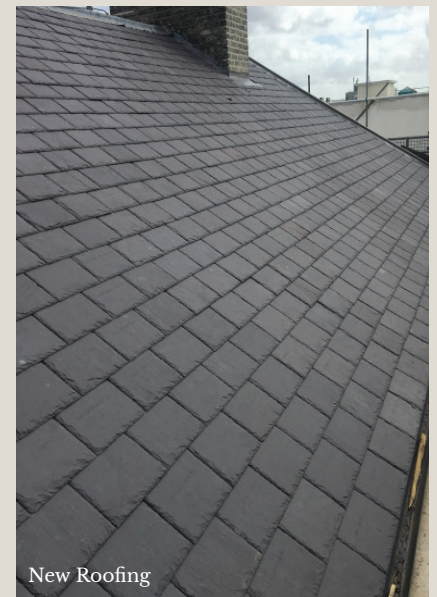
New Roofing

- Joinery repairs to roof encompassed treatment of all internal wood structure with wood preservation. Timber repairs and re-roofing were carried out as required including stripping of all battens and slates.

- Lead ridges to the South and East were found to have inadequate coverage to affect a water-tight seal and were replaced in full. As well as new flashing and cladded in code 6 lead.

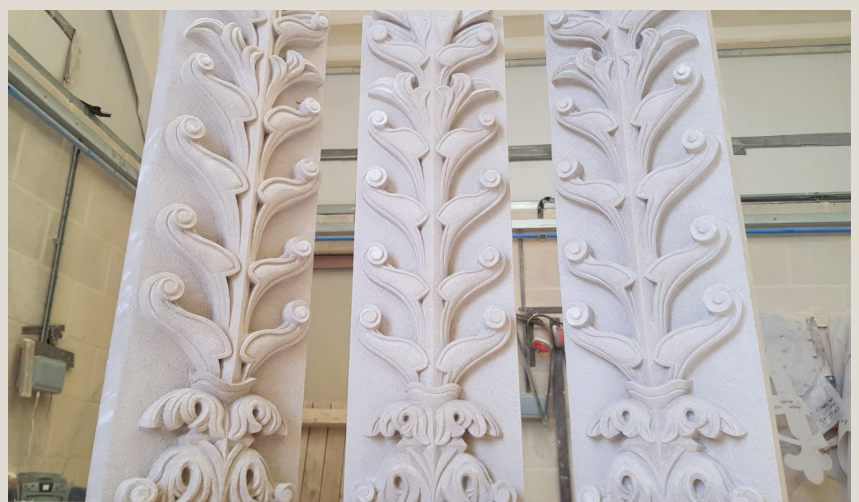
Completed new carvings for Pepper Pots
