York Minster

REVEALED

York Minster Revealed is a £20million, five-year project (the largest of its kind currently under way in the country) to restore the East Front of the Minster and improve access. The work includes a major restoration of the magnificent tracery window with its 145 stained glass lights.

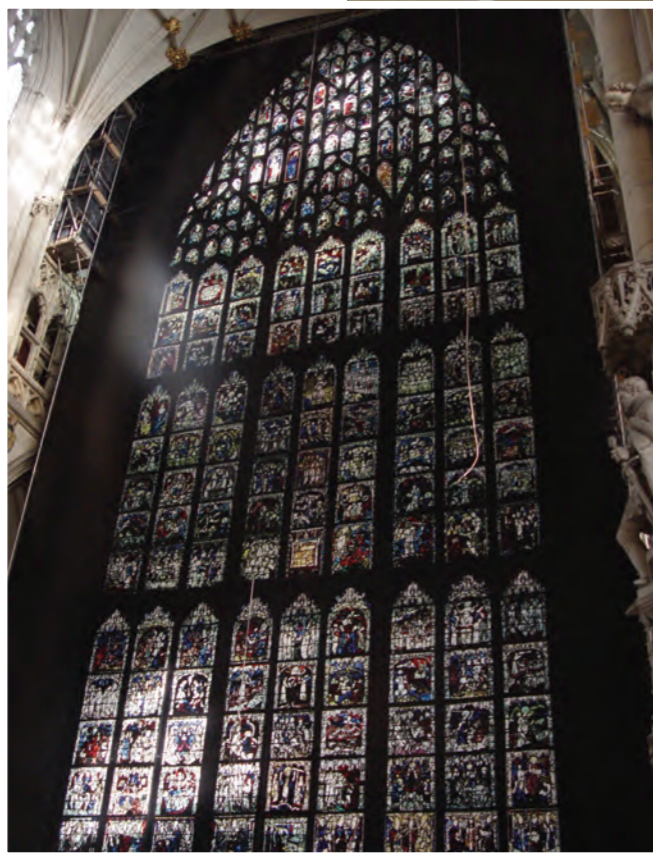
Above. The drape over the window at the East Front of the Minster behind which masons are restoring the magnesium limestone tracery.

The window itself has been covered by a drape containing a full-size picture of the stained-glass and tracery it hides. Behind the drape, the glass has been removed and masons are working, replacing some of the masonry and consolidating other sections.

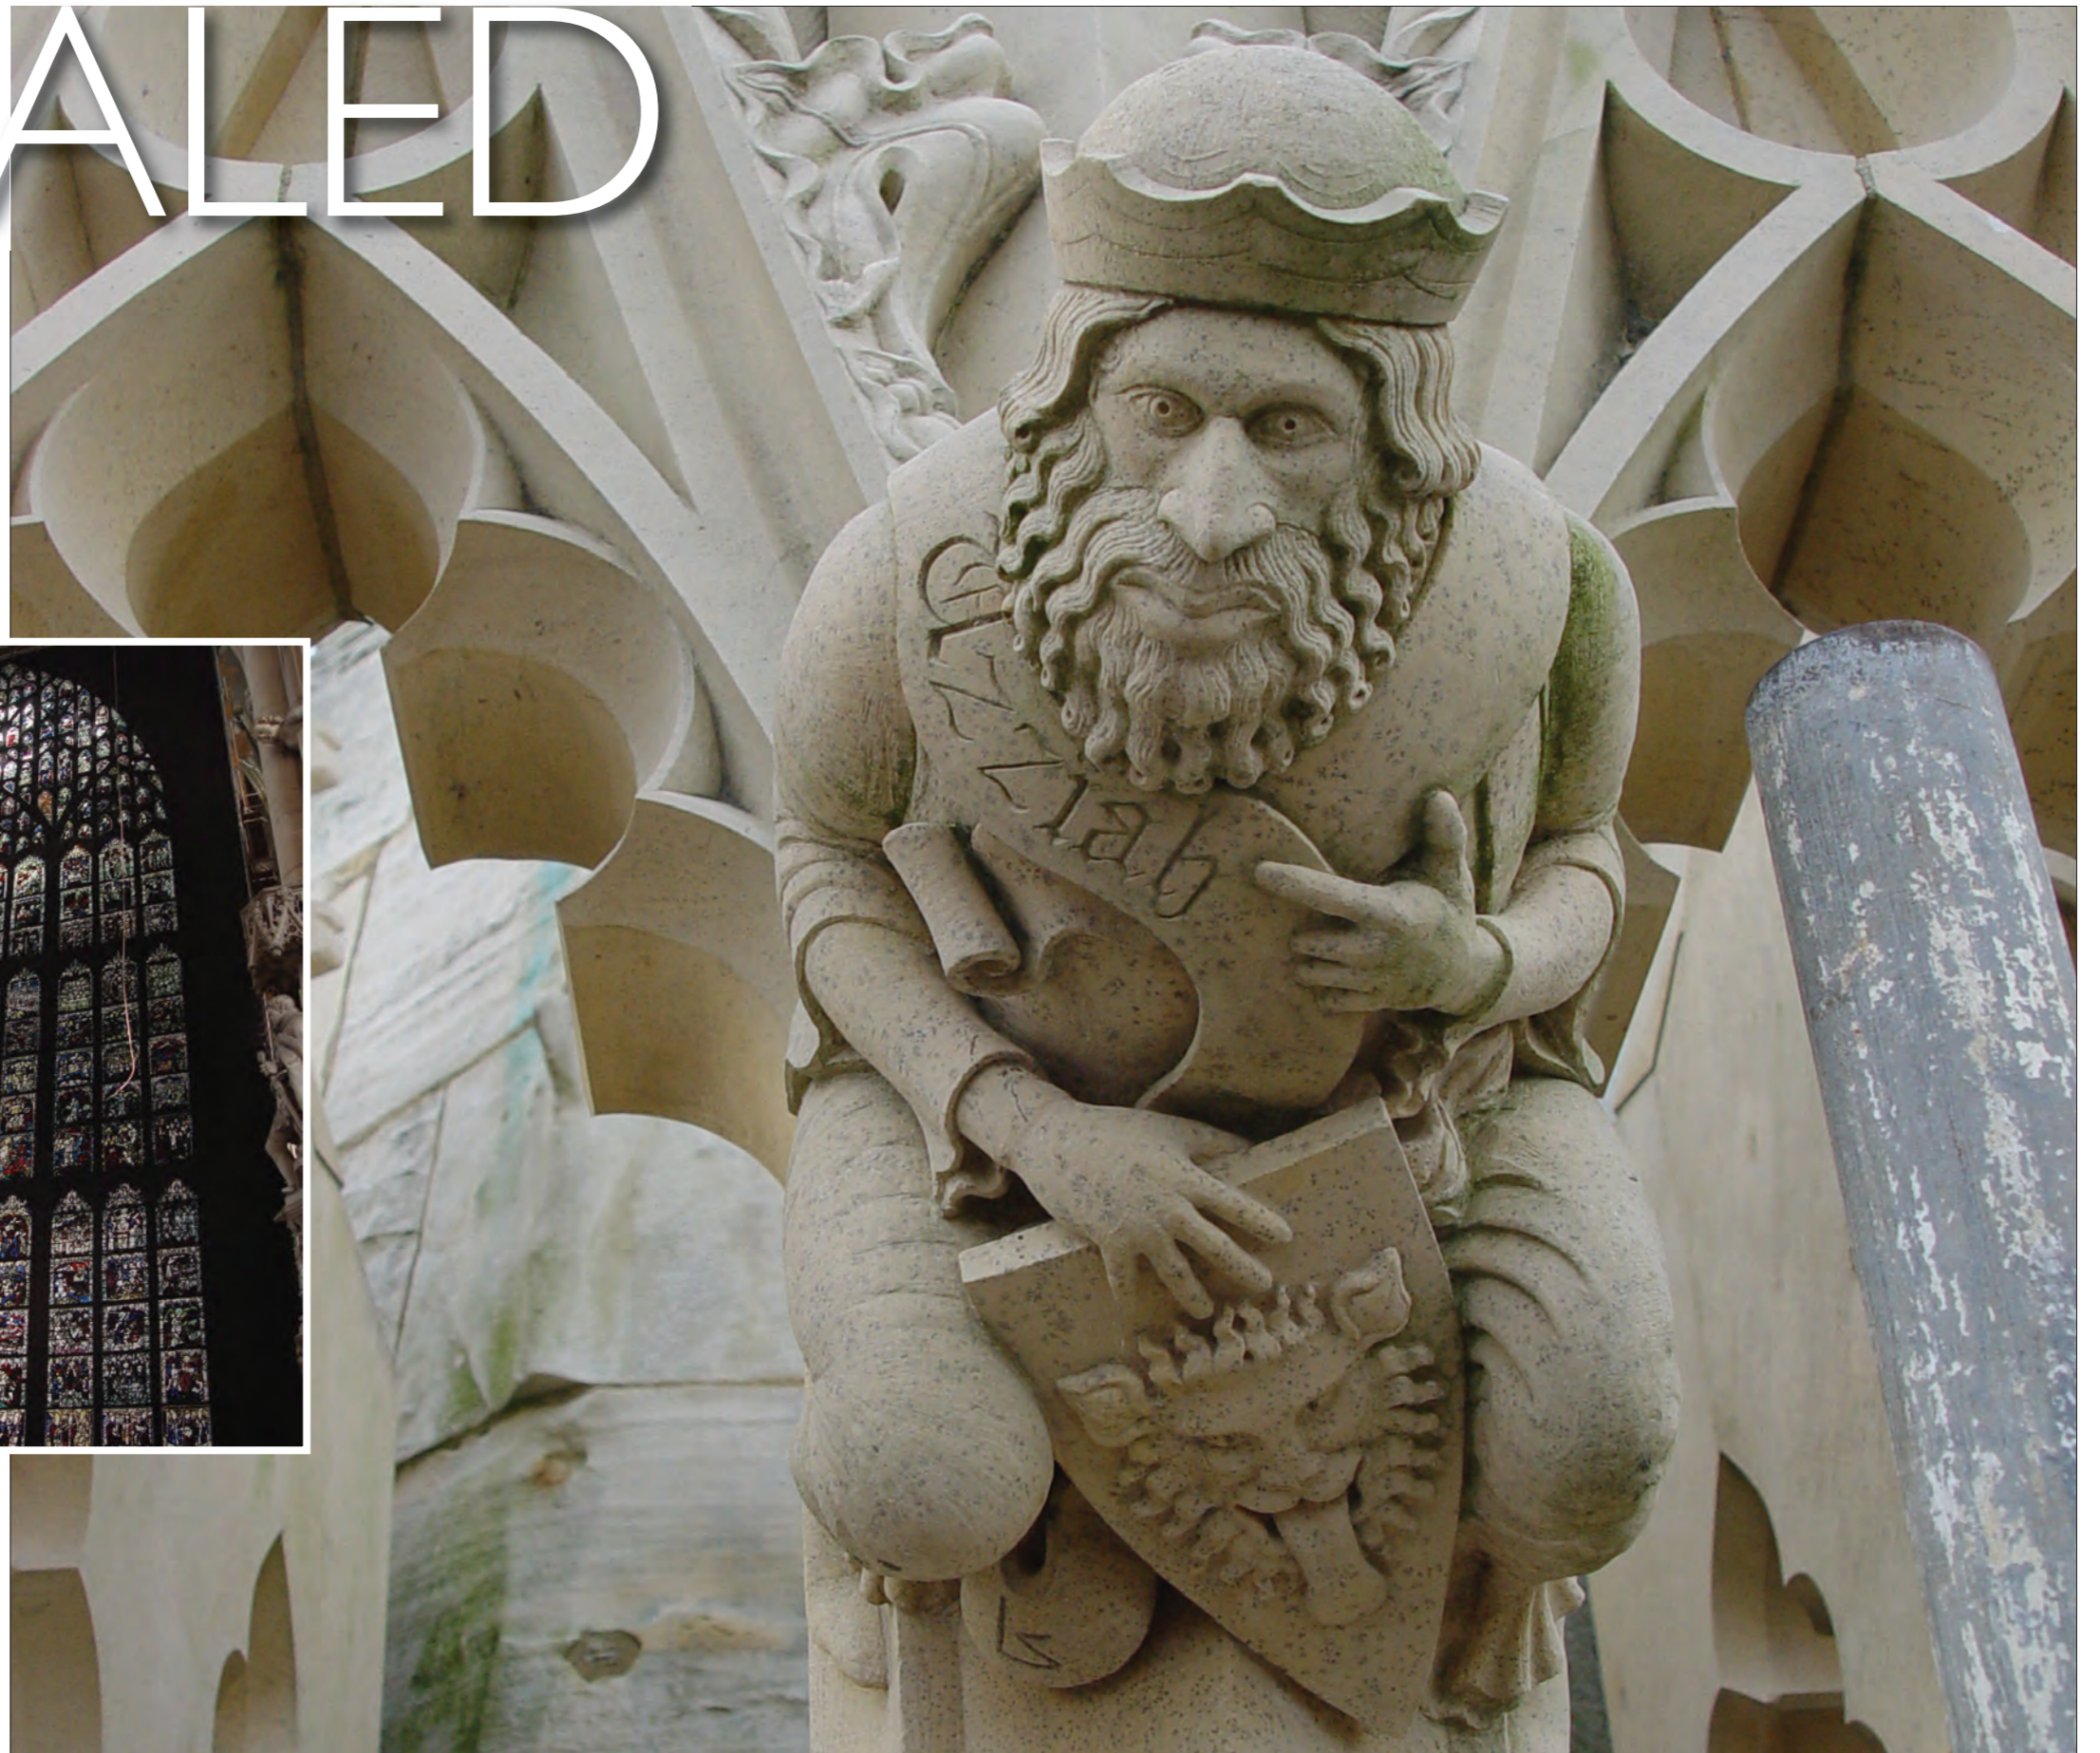
Right. One of the carvings and new masonry on the rebuilt southern buttress of the East Face of the Minster that gained the Minster's masons top honours in the Craftsmanship category of the Natural Stone Awards in November.

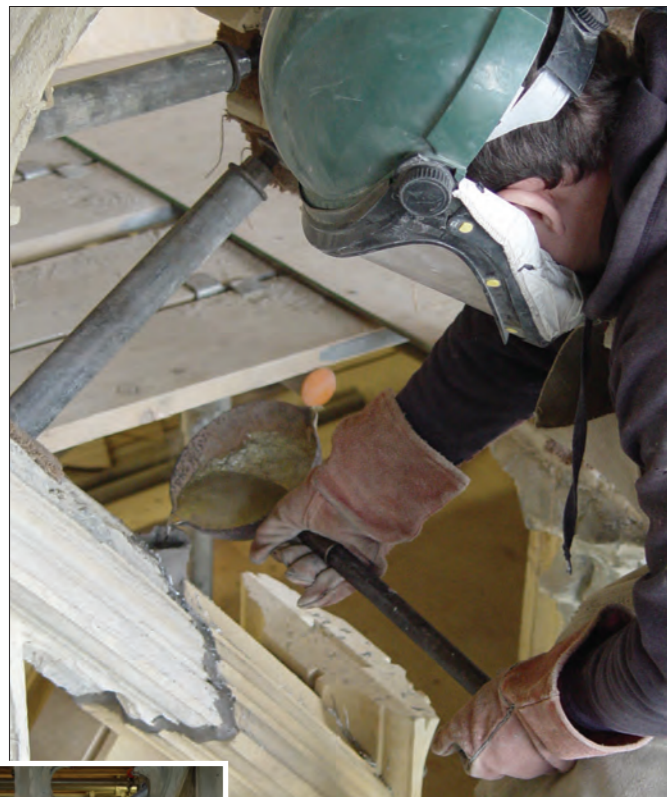
Above. The masons at the Minster have learnt from their predecessors and are using molten lead to create the joints between the stones of the tracery on the Great East Window. This is Lindsay Hogarth pouring the lead.

In fixing, too, today's masons are following the example of their predecessors. The joints between the stones in the tracery of the window are filled with lead. Lead spacers hold the stones apart when they are positioned in the window, clay is pushed into the gap at the edges and molten lead is poured into the joint. Experience has shown the lead always fills the joint before it solidifies. The clay is then removed and the joint is pointed with hydraulic lime mortar.

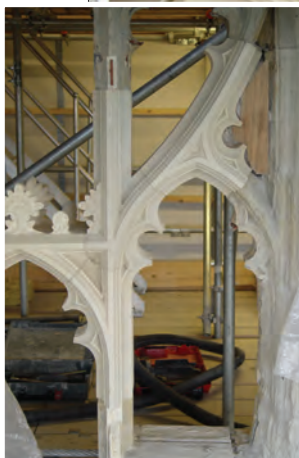
Below. Keim fillers are being used to repair the stone where it is still structurally sound. Nanolimes are also being used. John Sutcliffe is pictured here carrying out repairs.

Modern Keim mortar repair products are also being used and the Minster has been experimenting with nanolimes with the help of conservation consultant David Odgers. John David says it seems to be successful, although if too much is used it develops a bloom. It is not the first time the Minster has used stone treatments. It experimented with Brethane on the West Door a few years ago and in the 19th century the stones were coated with linseed oil, perhaps to stop soot accumulating. But it sealed the stone, preventing moisture migration and leading to the growth of magnesium sulphate crystals that created spalling.

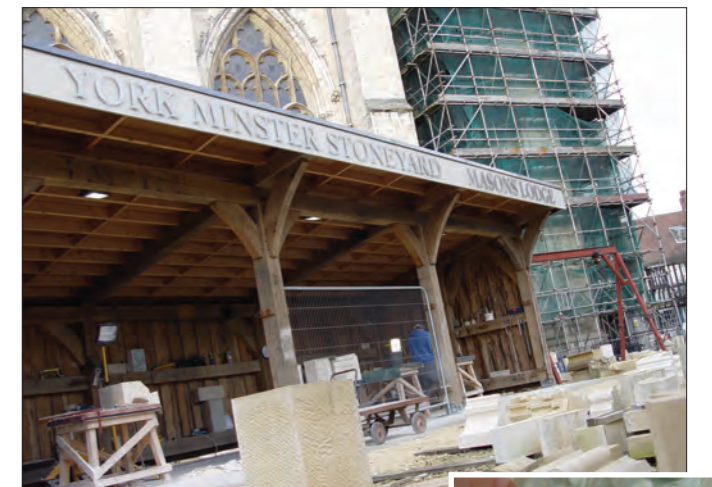
Above. The Mason's Lodge, where the public can watch the masons shaping the magnesium limestone.

The current project goes under the name of York Minster Revealed, because an integral part of it is to inform and educate the public. One aspect of that has involved building an open air mason's lodge at the bottom of the scaffolding so the public can watch as the magnesium limestone is worked into new elements of masonry.

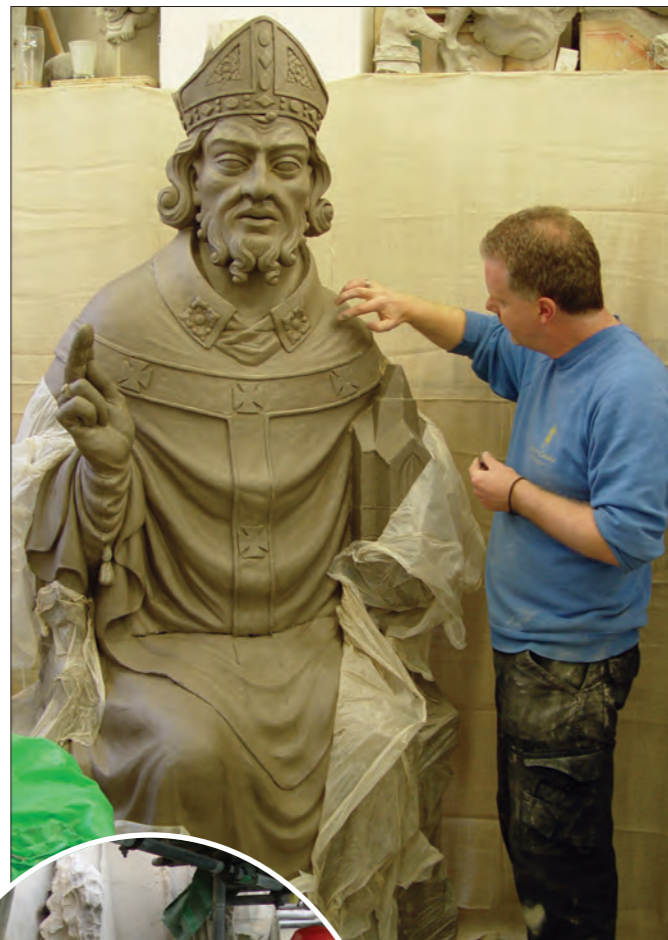
Above. Martin Coward creating the clay maquette for the new carving of St Peter.

Work is progressing well on a full size clay maquette of St Peter following the approval of sketches. The clay of the maquette is being built up over a cast taken from the original statue to help maintain the original proportions. Once the maquette is approved, work can begin on the three pieces of stone that will form the finished statue. Great care has been taken to ensure water will run off it rather than collect anywhere on it.

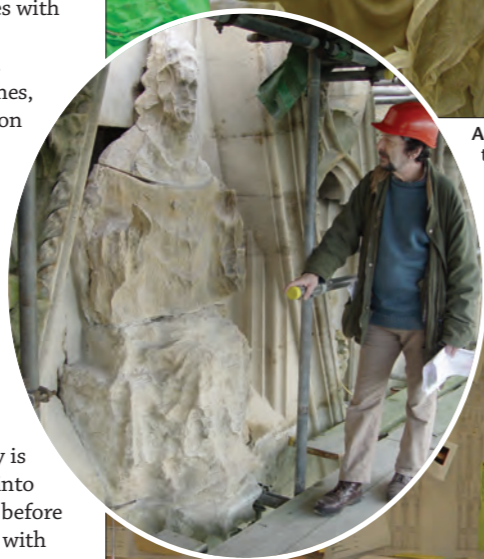
Left. The weathered remains of the original carving.

One of the most important carvings on the current project is the replacement of a heavily weathered statue at the top of the East Front. The general consensus of opinion is that it was originally St Peter, especially as the Minster is the Cathedral Church of St Peter. The statue looks as if it might be holding a church, which is how St Peter is often depicted.

The height of the head of what remains of the original statue suggests it might originally have sported a papal coronet rather than a bishop's mitre, which would fit with the age of the statue, thought to date from the time the East Front was built. However, it is thought unlikely that a papal coronet would have survived the Reformation and the new carving, being produced by Martin Coward, has the mitre of an Anglican bishop.

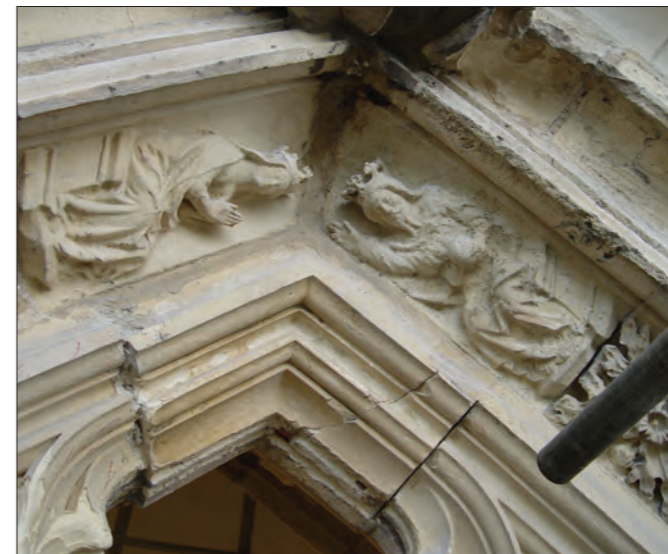
Above. Carvings around the edge of the Great East Window have been sheltered by the moulding and are still largely in good condition. These two at the top are generally considered to be the coronation of the Virgin Mary on the left and Christ in Majesty on the right.
