CASE STUDY

### Places of Worship

Universal Stone are pleased to have worked with leading RIBA architects Carden and Godfrey at St Nicholas Church in Chiswick, recently completing essential external masonry repairs and conservation works to the North Elevation.

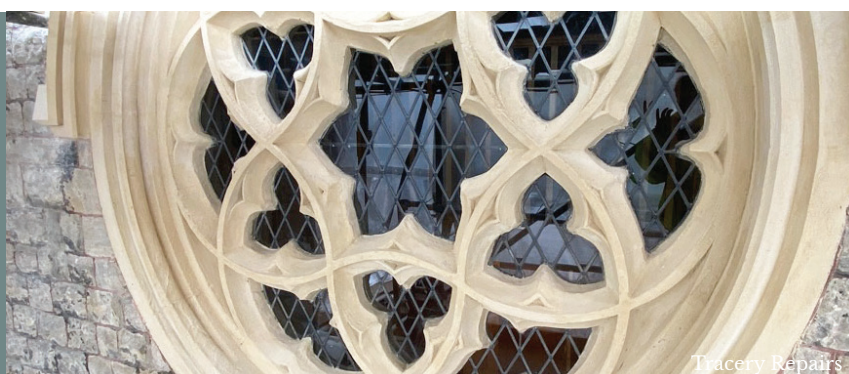
Tracery Repairs

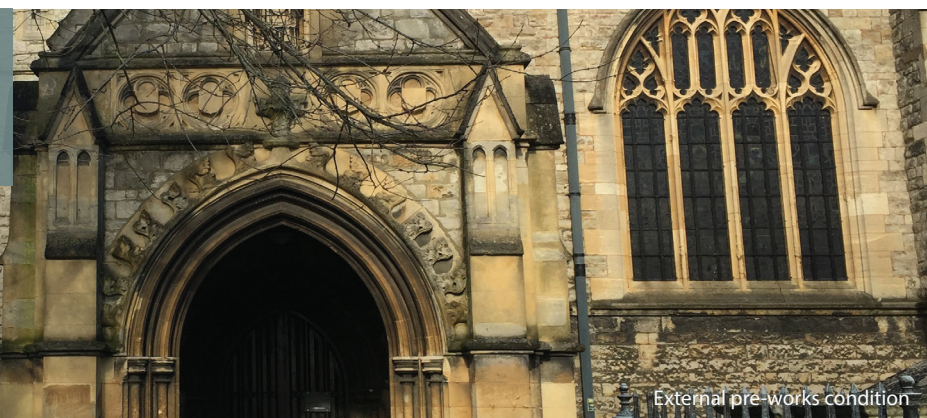
External pre-works condition

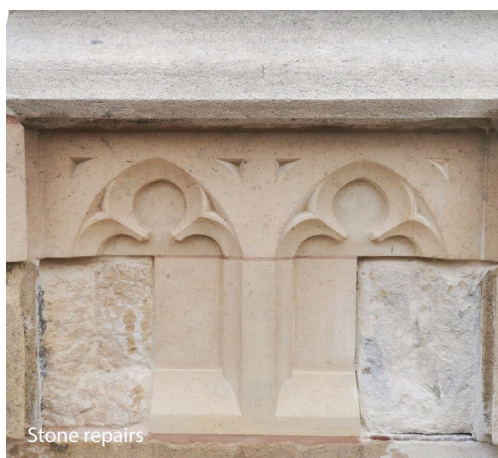
Stone repairs
