120/121 SLOANE STREET

External Refurbishment

Project Overview

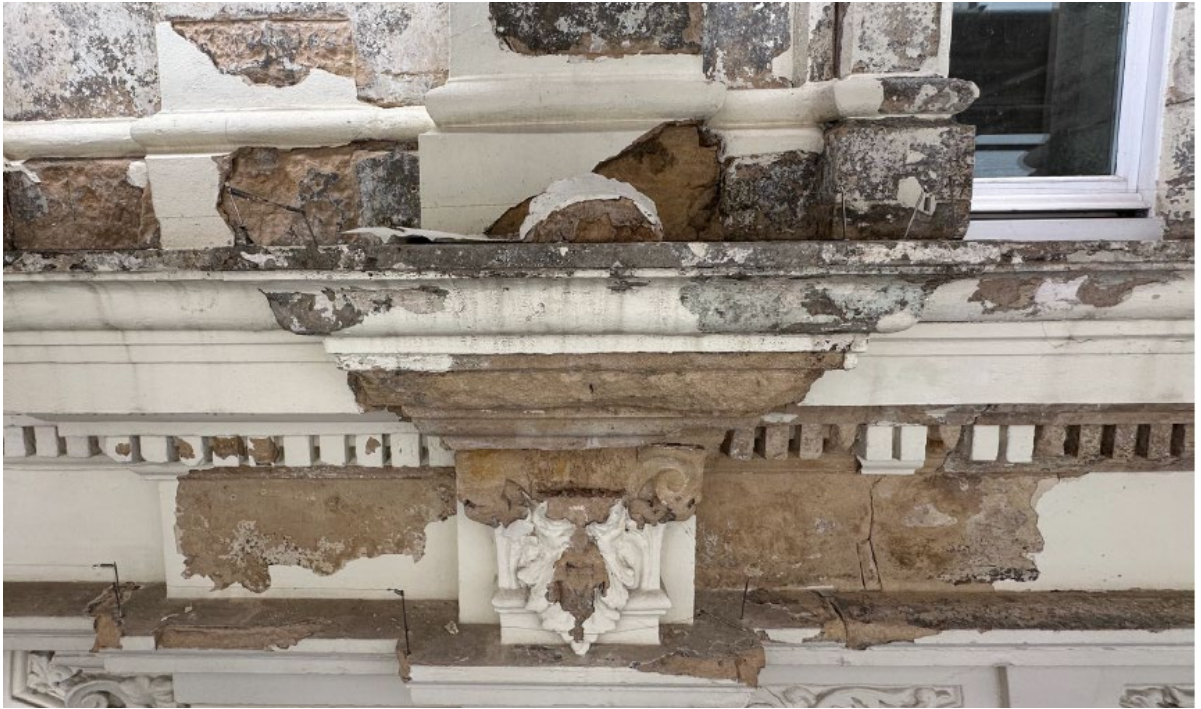
Extent of Bath Stone Repairs required, before works commenced.

Due to the specialist nature of the repairs to the bath stone necessary for this project, six of our in-house restorers were deployed solely for this project, closely followed by our in-house decorating team. No subcontractors were deployed for this project, which was subsequently completed on time in spite of the significant increase in the number of repairs required to the façade. On completion of the stone repairs, the front façade was redecorated using Keim paint products by our in-house decorating team.

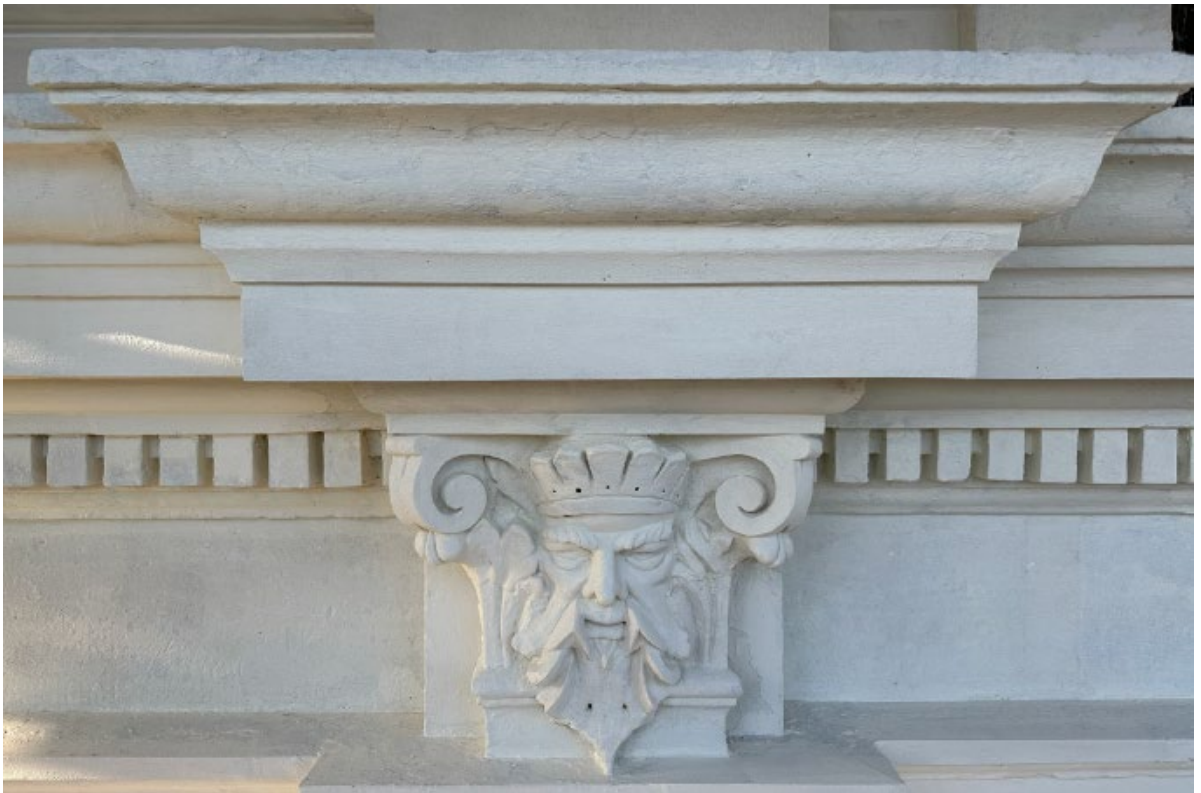
Completed Bath Stone repairs and redecoration.

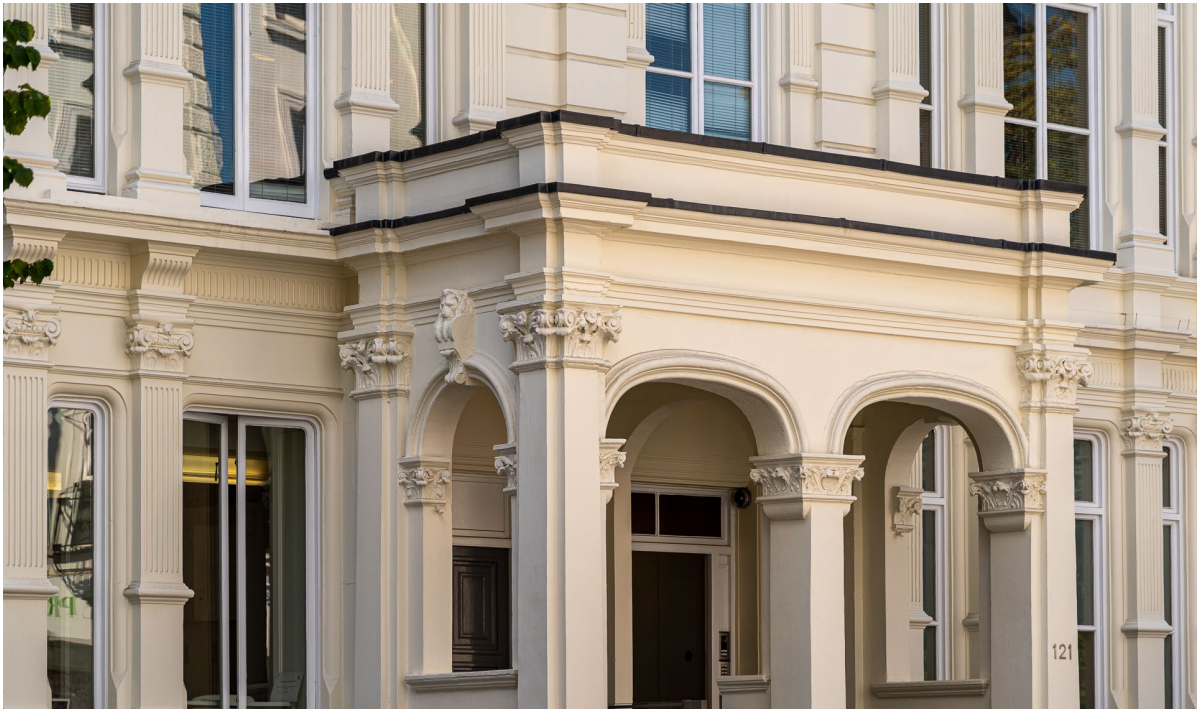
Completed: New Lead Capping's to Restored Portico

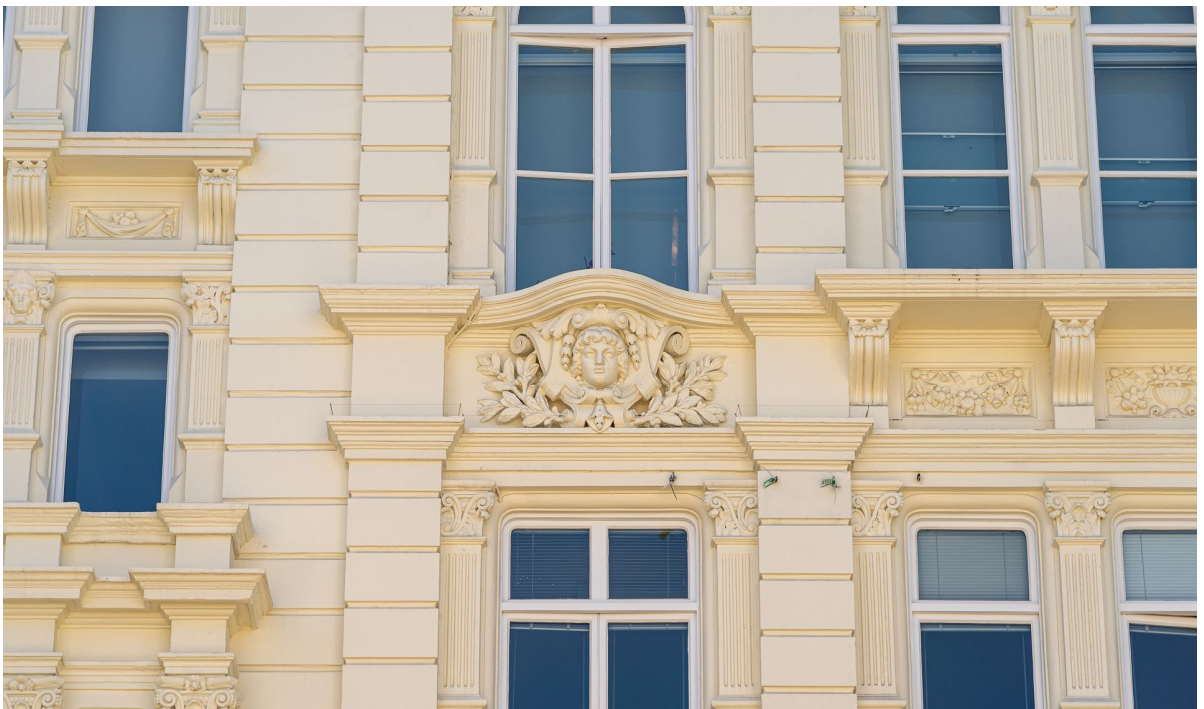
Completed: Restored Ornate Bath stone Gargoyle

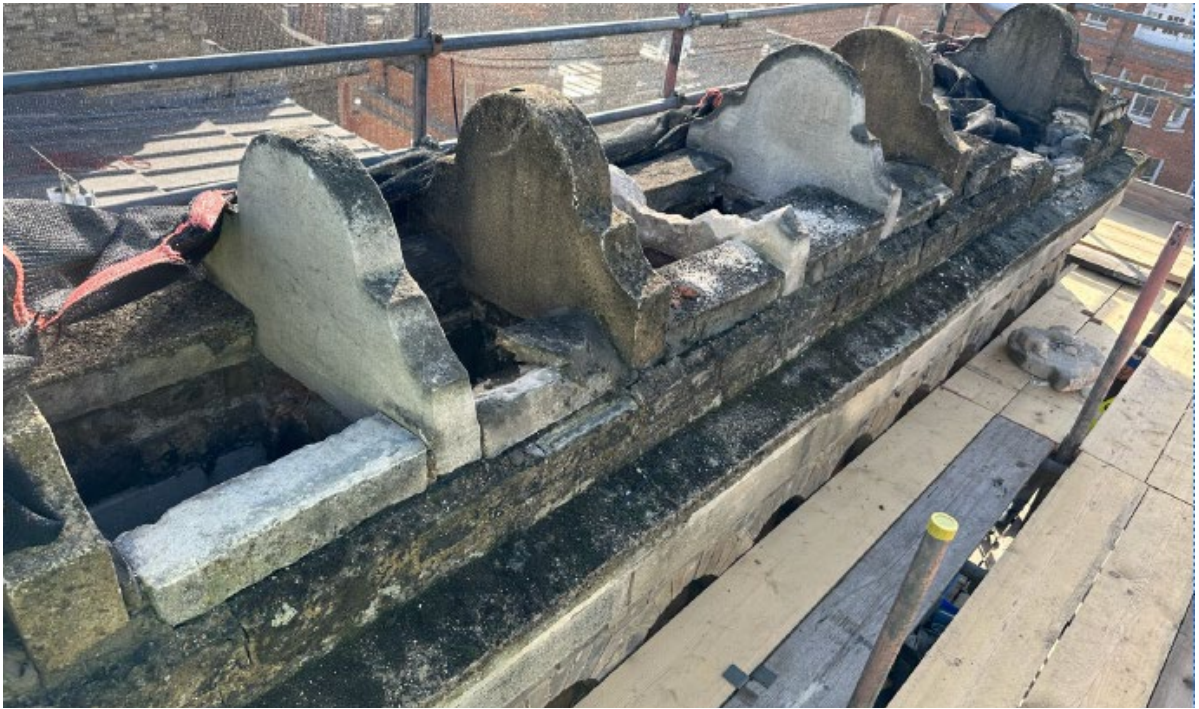
Overview of the wrapped section of the end slack before rebuilding works commenced.

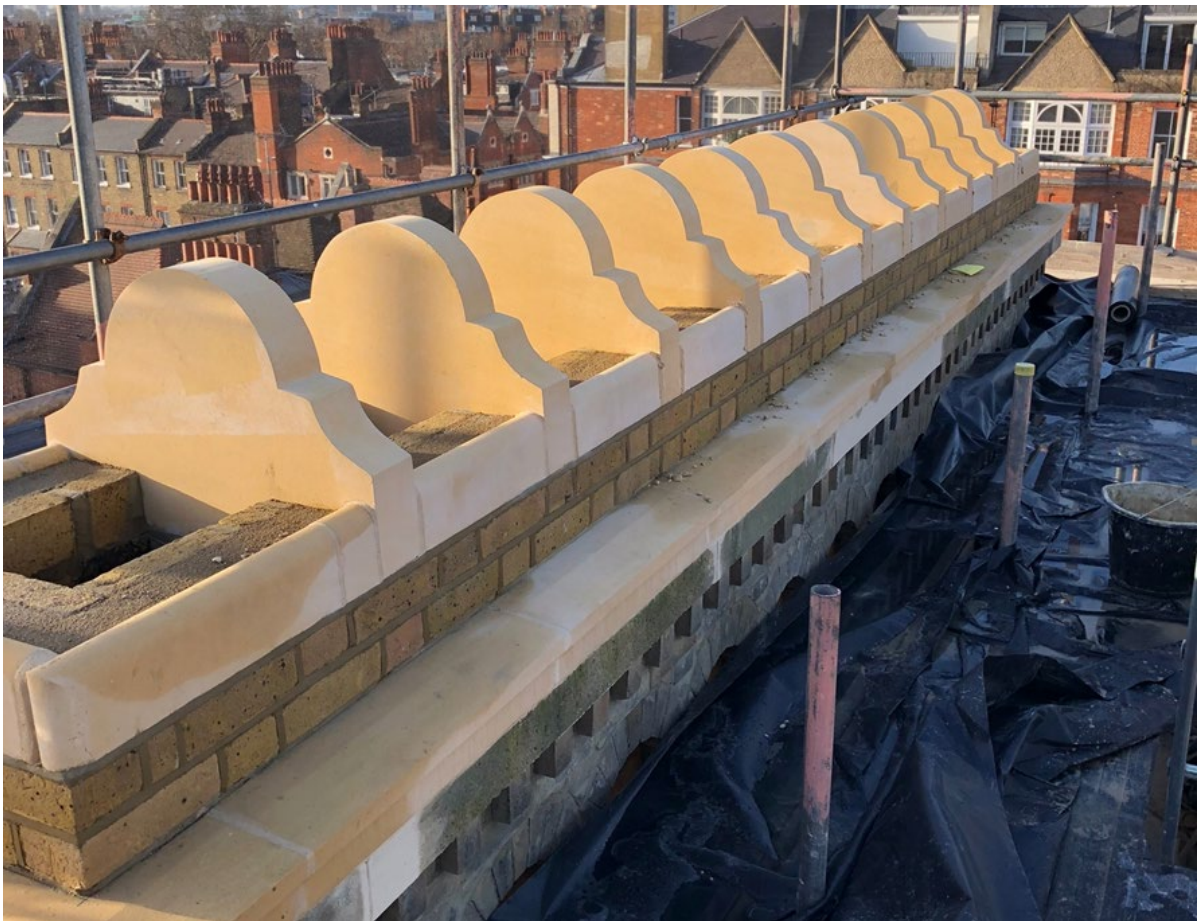
Newly constructed top section of stack, using reconstituted Bath Stone and new yellow stock bricks.
